A GENTLEMAN'S GUIDE TO SMITHS ELECTRONIC TACHOMETERS

A gentleman's guide to Smiths electronic tachometers

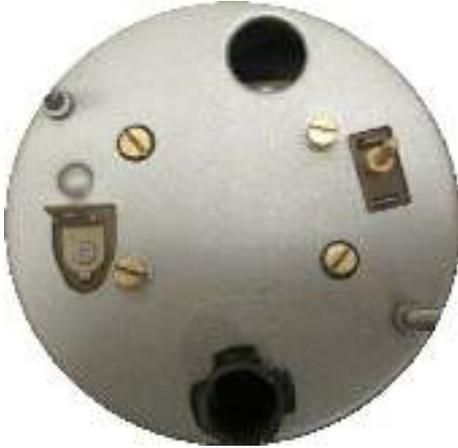
RVI Gen-1 OEM tachometer:

This is the Gen-1 OEM tachometer which has one of the power supply connections electrically connected to the metal case. In many cases the "red-line" will be marked on the dial but not always. Similarly, polarity will be generally be marked on the dial as shown but this also may not always be the case.

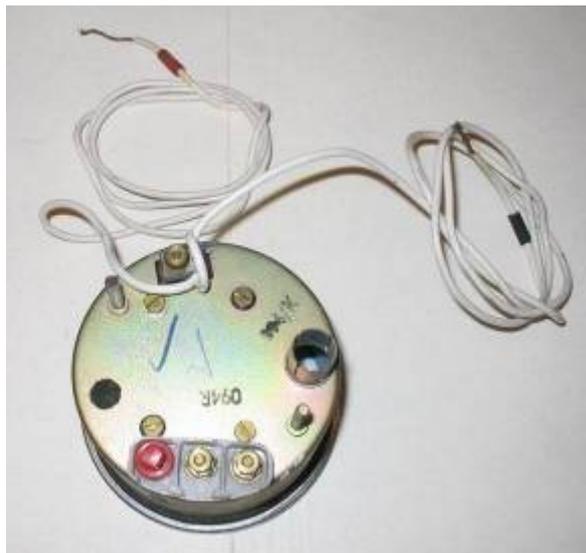
RVI Gen-1 accessory tachometer:

Picture at left is the Gen-1 accessory type tachometer. The main difference here is that there is no electrical connection between the internal circuitry and the instrument case. Two or three terminals for power supply connection are provided as can be seen in the lower part of the picture. This particular example has two connection terminals, the third terminal being covered by a red plastic cap. The centre terminal is the positive connection. The right-hand terminal, as shown in the picture, is the negative 12V connection and where provided (uncapped), on early production units, the left-hand terminal is the negative 6V connection. The early impulse pickup assembly is shown in detail below.

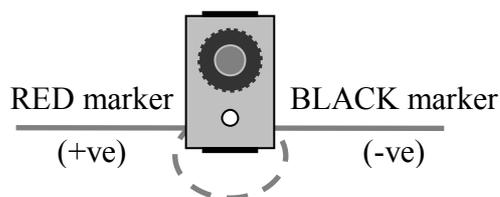
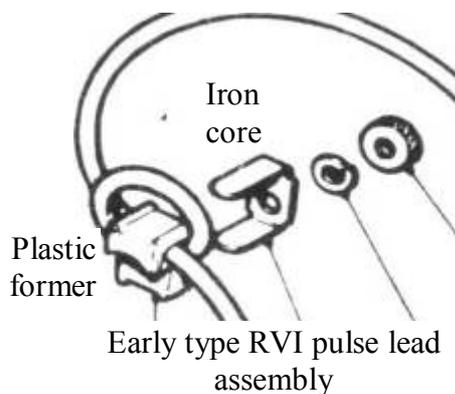
The figures below show the wiring for the pulse lead block attaching to the back of Gen-1 instruments. Accessory type instruments had coloured markers at the end of the long pulse leads when new but these markers were almost always cut off once the tachometer was fitted to a vehicle. Since the sense (or polarity) of these connections is critical to the operation of the tachometer, the sketch below is provided to assist in getting it right first time.

View of assembly as mounted, from rear of tachometer. Dashed line is the loop present on factory/OEM instruments but may be removed for use with higher current (>4 Amps) ignition coils.

A most important piece of the pulse lead assembly of the early RVI tachometer is the "Iron core". Without it, the tachometer will not work! One could easily be made if required. This "little bit of tin" completes the magnetic circuit that allows the tachometer to sense pulses. ***It is a fairly simple matter to make a new iron core. See Appendix C to this document for details.***

The plastic former shown in the diagram holds the pulse lead in place to prevent the wire chafing against the case and shorting out. A replacement could be fabricated from a piece of polyethylene (from an old plastic chopping board for example).

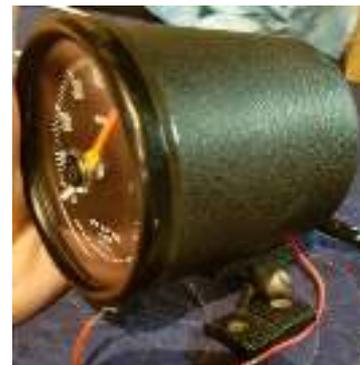
Accessory tachometers are 3 inch diameter instruments. (There may have been a 2 inch type.) Smiths also produced an optional aluminium pod and mount to house these. A special mounting bracket was a part of the pod kit which allowed the instrument to be secured with a single screw at the rear of the pod. These were commonly used when fitting tachometers to Minis. Similar pods were used in some Volvo vehicles. Photo at right shows an accessory tachometer fitted to a pod.

Suitable mounting pods such as this are advertised on the internet and may be available locally in some areas. (Photo supplied by Mark Olson.)

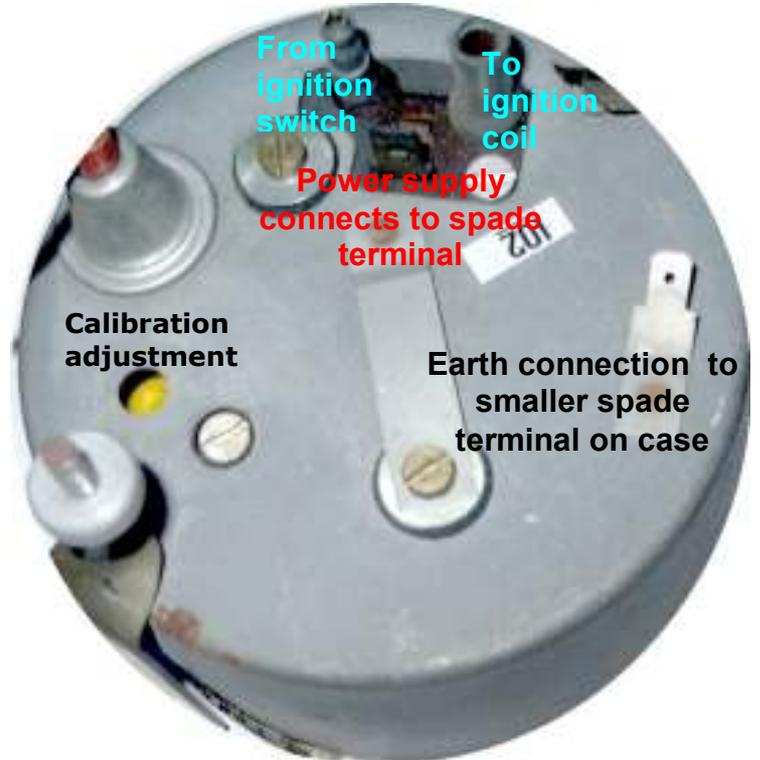
Pulse connectors (bullet type)

One instrument found fitted with the alternate board is an RVI 1050/06A (right) which was fitted to Rover 2000, some Morgan vehicles and possibly supplied in other BMC cars. Note the presence of a marked "red-line" area which identifies this as an OEM instrument. It may have been fitted to early production, positive earth, models. This is a 3 inch diameter instrument with a spun-on bezel but no polarity marked on the dial (for this particular negative earth instrument). One of the power supply terminals to this unit is connected to the case. One would hope that any positive earth instrument of this type would be marked "POSITIVE EARTH" on the dial. Changing polarity involves opening the case which may require a new bezel. Check tachometer polarity if unsure (see "Checking an electronic tachometer" later in this document).

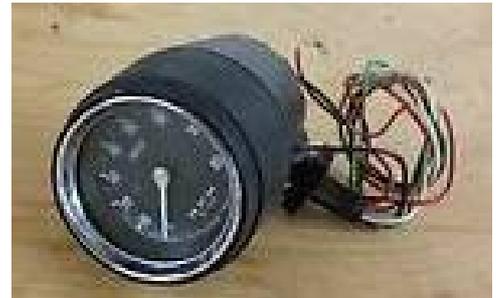
The plastic-cased RVI 5000 series variant shown at right used the later blocking oscillator circuit. Isolation of the internals from the vehicle chassis allowed these to be fitted to both positive and negative earth vehicles. These were also fitted to some Volvo vehicles as standard equipment and marked RVI 5411/xx and RVI 5413/xx. The difference between the accessory and OEM versions is the provision of a 6 Volt connection option inside the rear of the case of the accessory tachometer. The rear case cover simply pops off to provide access.

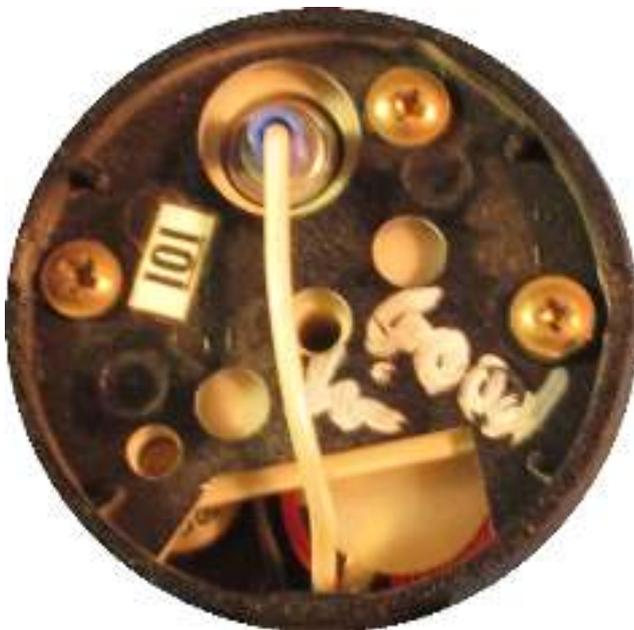
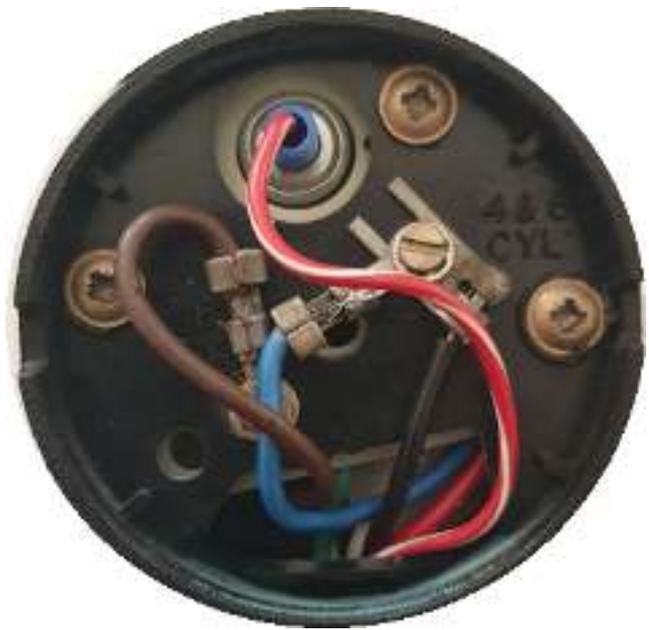
The following pictures show, at left, the rear view of an OEM tachometer, without a voltage select option with the cover removed. The right-hand picture shows the same view of an accessory instrument and the voltage select terminals. Blue wire is the -12V connection as can be seen here, the brown wire the -6V connection. The black wire is the lead to the vehicle's negative supply. Changing voltage simply involves transferring the black wire to the terminal corresponding to the required voltage.

(Left-hand photo supplied by Mark Olson)

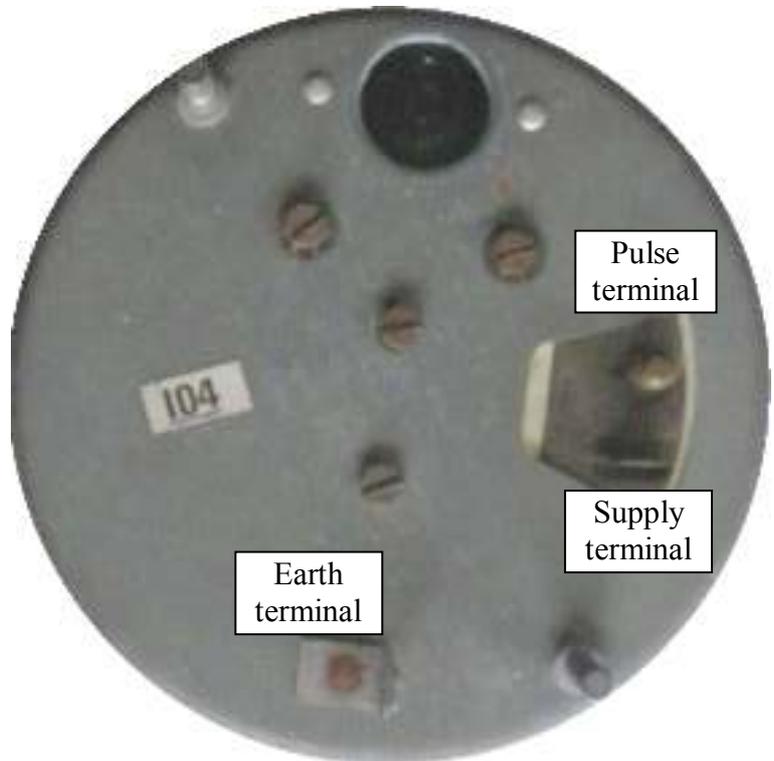
Connections in a late model RVC OEM device consist of a blade connector for power supply, a spade connector spot-welded to the case for negative or earth connection and a single “bullet” type connector for the pulse lead as shown at right. The “Y” mounting screw layout of the Gen-4 instrument is plain to see here.

There were also caseless versions of the Gen-4 instruments manufactured. Gen-4 caseless instruments (e.g. RVC6419/00) were fitted to Triumph TR7/TR8 cars and possibly in other marques.

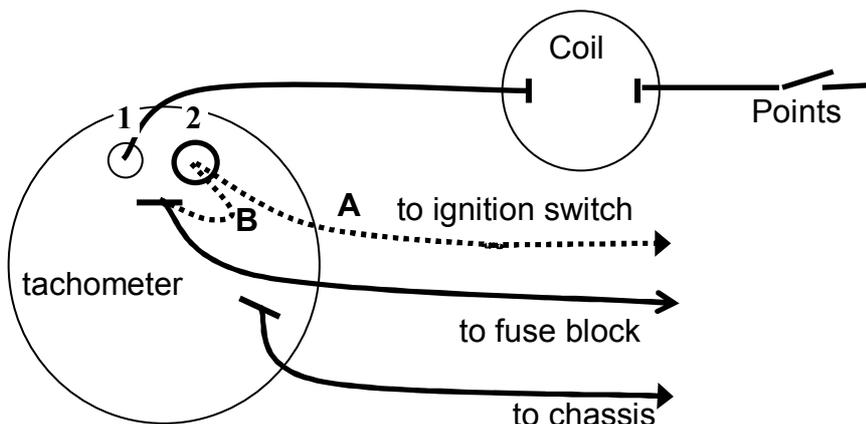
The diagram below shows how to connect the Gen-2 RVI OEM instrument. Illustrations in Appendix A show the earlier type.

While it is possible to place a jumper as shown at "B", the connection "A" represents "best practice" with the power to the instrument from a fused supply.

This should have the tachometer displaying rpm with the engine running. If not, check first for smoke (supply polarity wrong) then for 12 volts between the case and the spade terminal. If this is OK then swap connections to terminals 1 and 2. If the tachometer is still not working then it needs repair.

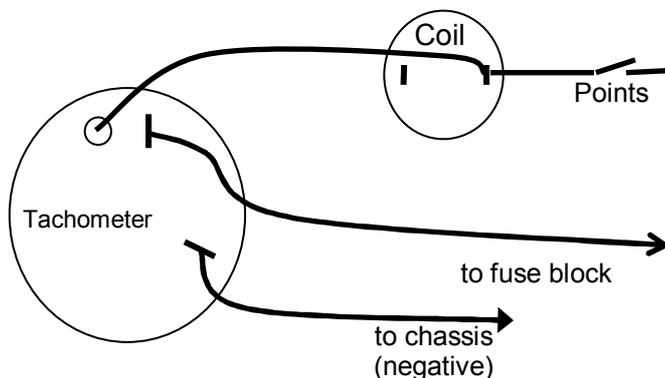
The sketch below shows how all OEM RVC tachometers are connected. The accessory tachometer is wired similarly though the terminals style differ – refer Appendix A.

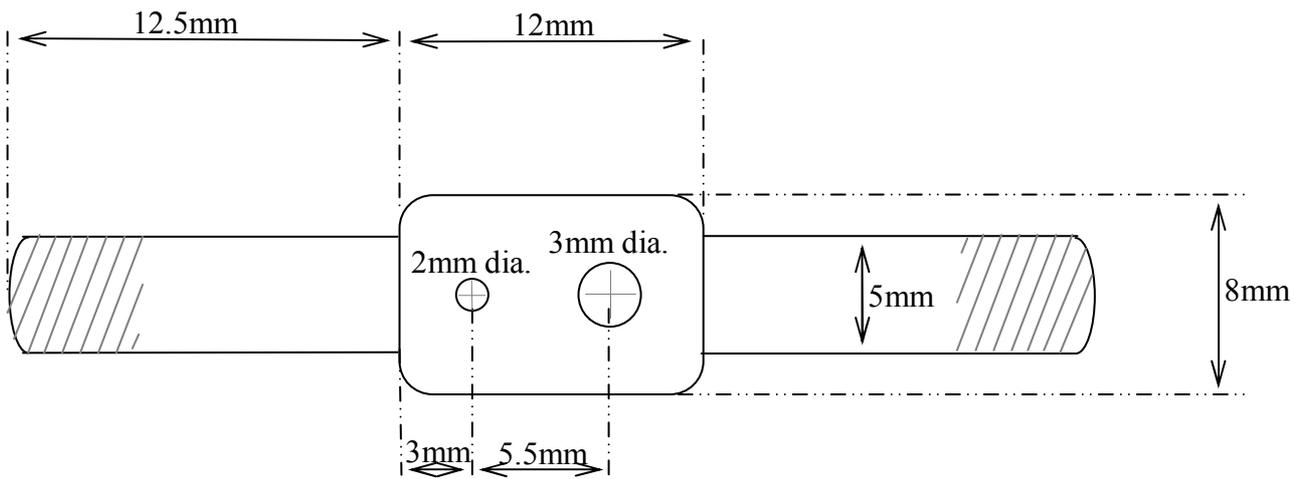
When making these, I have always used transformer core laminations.

The extra width of the centre part is primarily to provide support around the mounting bolt hole. A strip of metal 5mm wide could be used for the whole thing but I would suggest in this case a brass washer is placed beneath the securing nut.

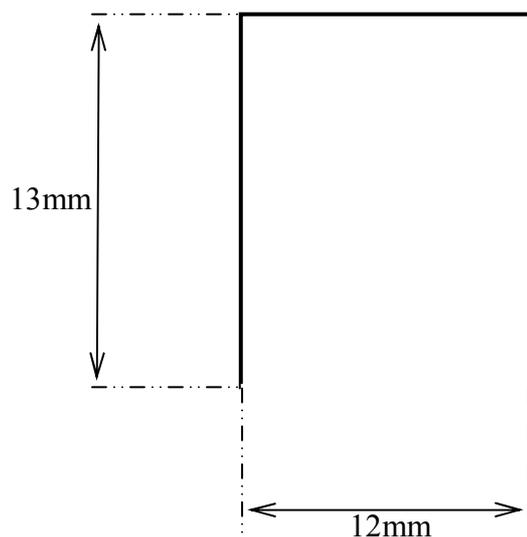
0.5 mm (25 SWG) soft iron
(annealed low-carbon steel).

Edge view of the finished clip.
Length of the legs should be within $+1/-0$ mm of that shown. The width of each leg should be within ± 0.5 mm.
